**REPORT  
OF  
COMMITTEE OF INQUIRY**

**ACCIDENT TO PILATUS PC-12 AIRCRAFT VT-ACF OF  
M/S AIR CHARTERS SERVICES PVT. LTD. AT FARIDABAD HARYANA  
ON 25.05.11**

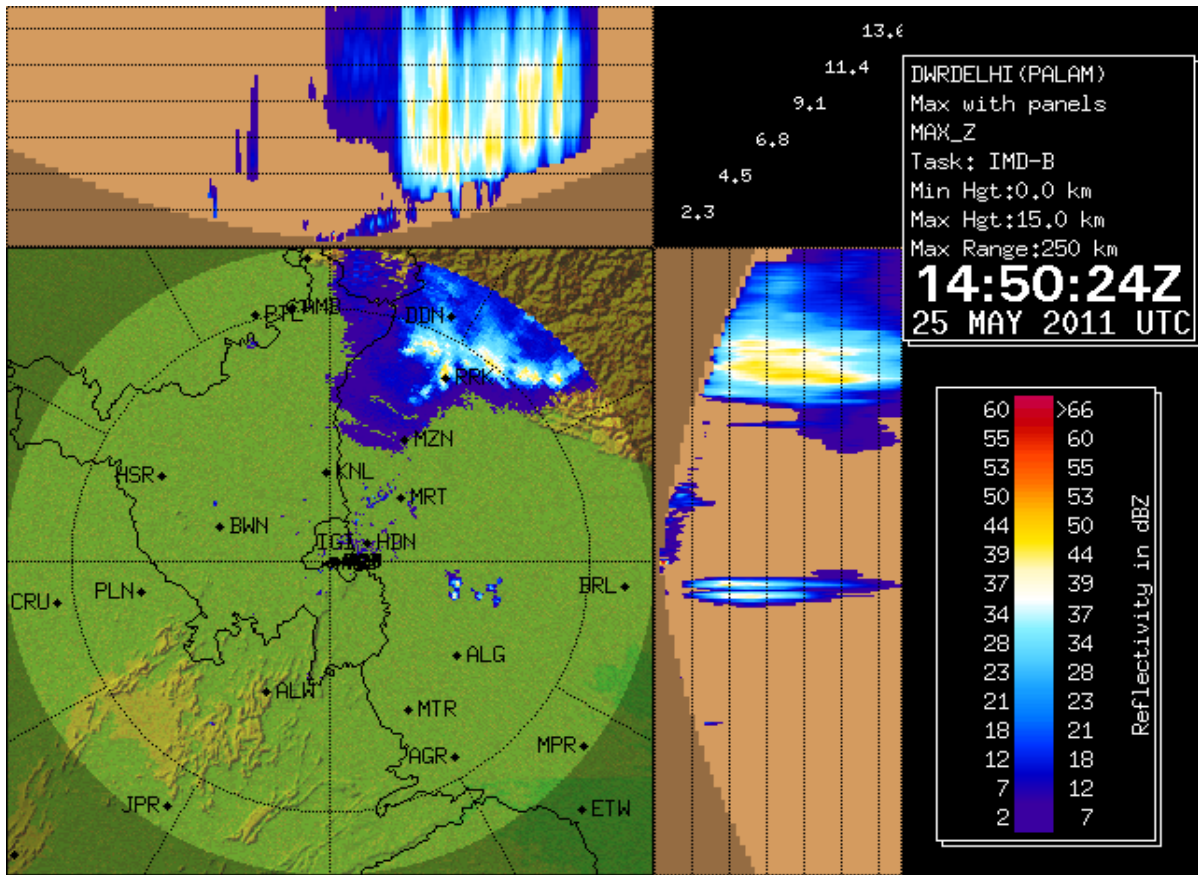
**Fig. 1. DWR Cloud pictures as early as 2020 IST confirms the development of vertically grown up CB clouds at NNE to IGI Airport at 100km to 200 km circles over Uttaranchal hills based upon which IMD issues warning of DS/TS and squally/gusty weather**

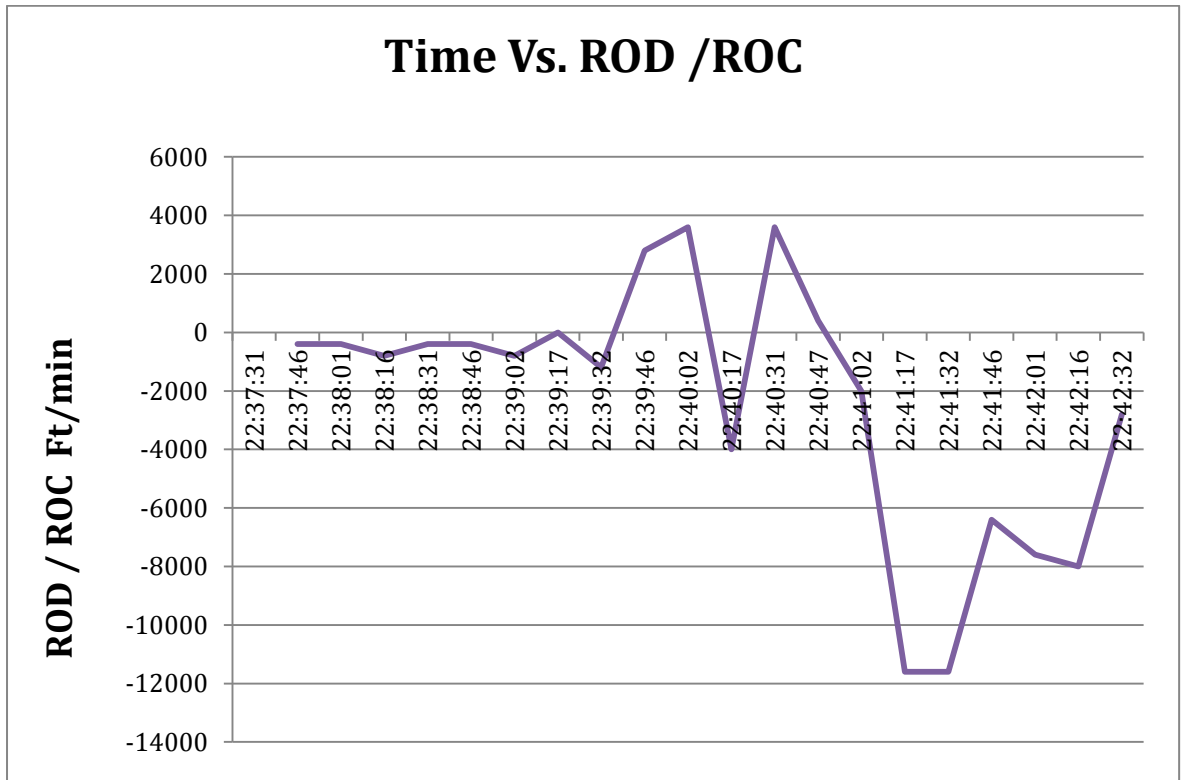
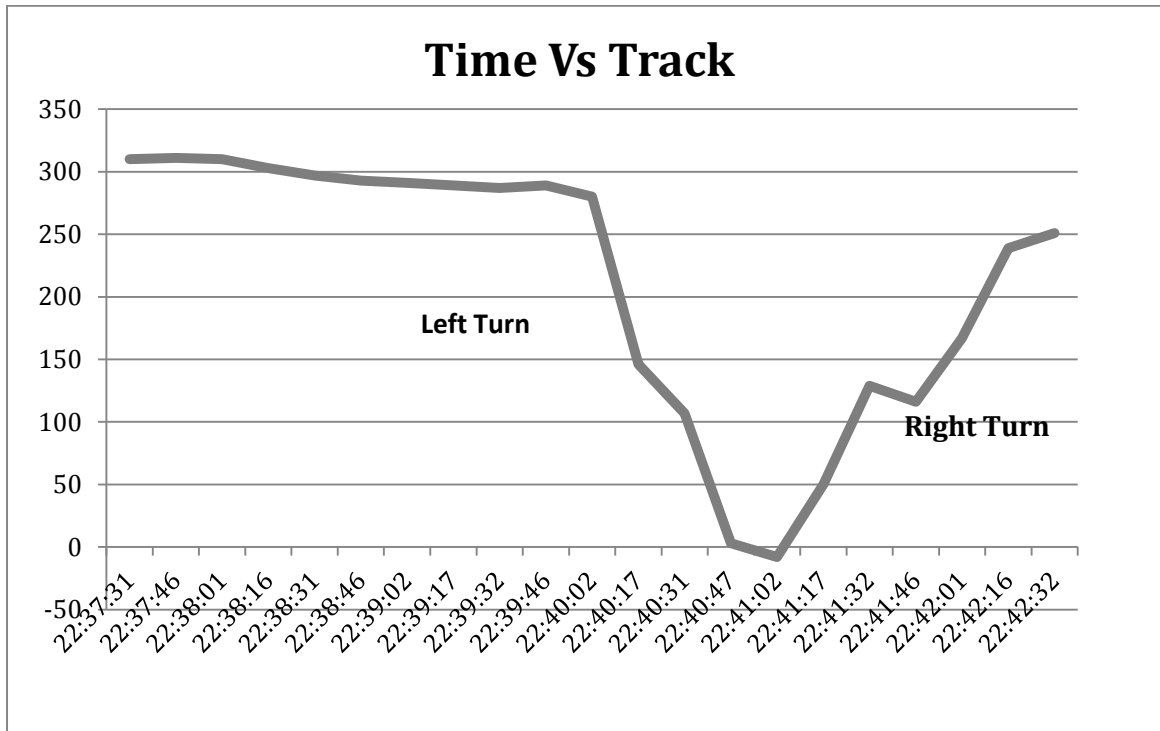
Fig 3. (From 22:37:46 IST to 22:42:32 IST)

Thereafter, the aircraft was in a departed state, with the ground speed rapidly reducing and a substantial and continuous loss of altitude. **The computed descent rates have been as high as 11,600 ft/min and the derived turn rate as high as 40 deg/sec (Refer Fig3. And Fig5.).**

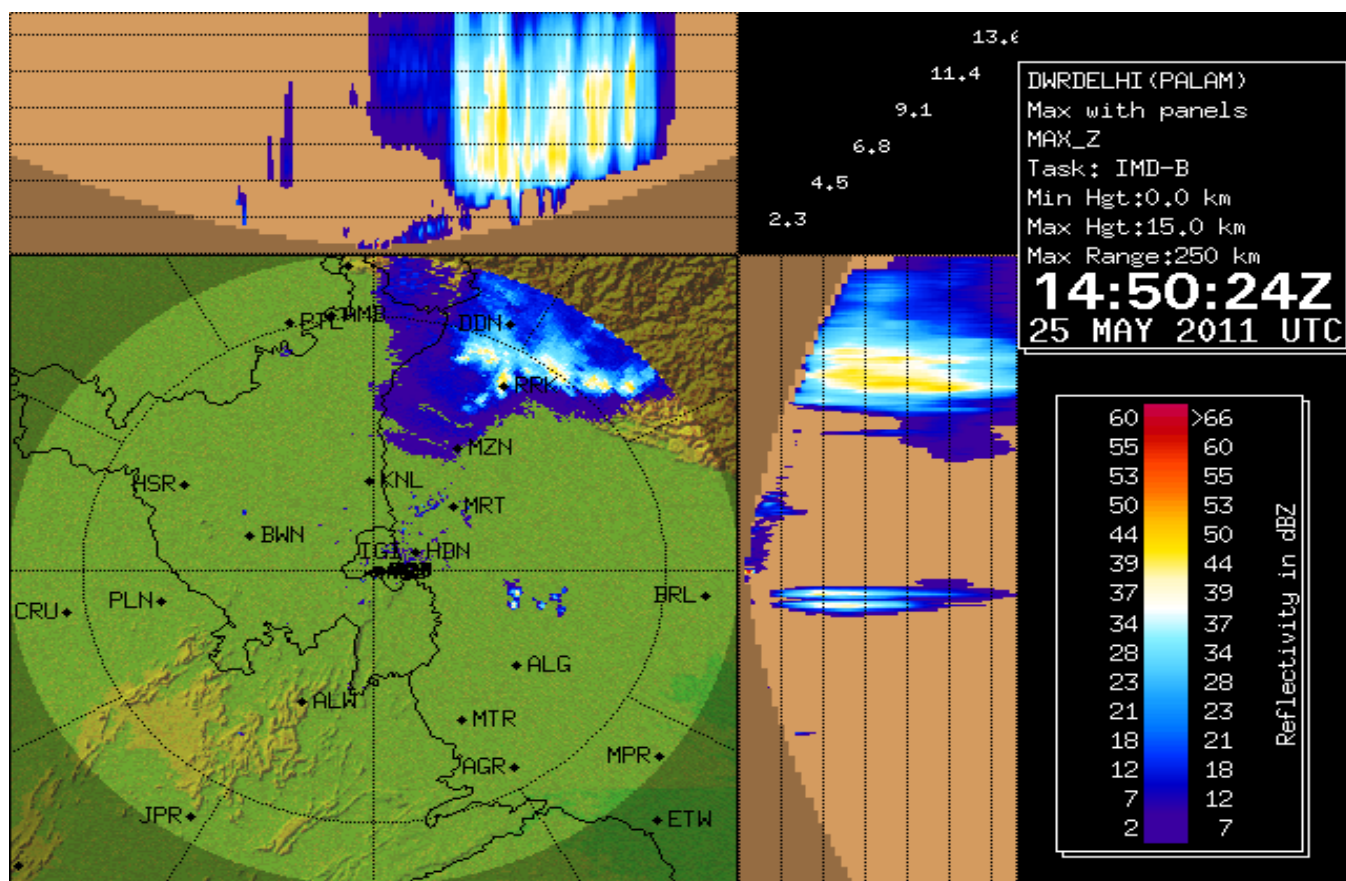
**Fig. 1.** DWR Cloud pictures as early as 2020 IST confirms the development of vertically grown up CB clouds at NNE to IGI Airport at 100km to 200 km circles over Uttaranchal hills based upon which IMD issues warning of DS/TS and squally/gusty weather

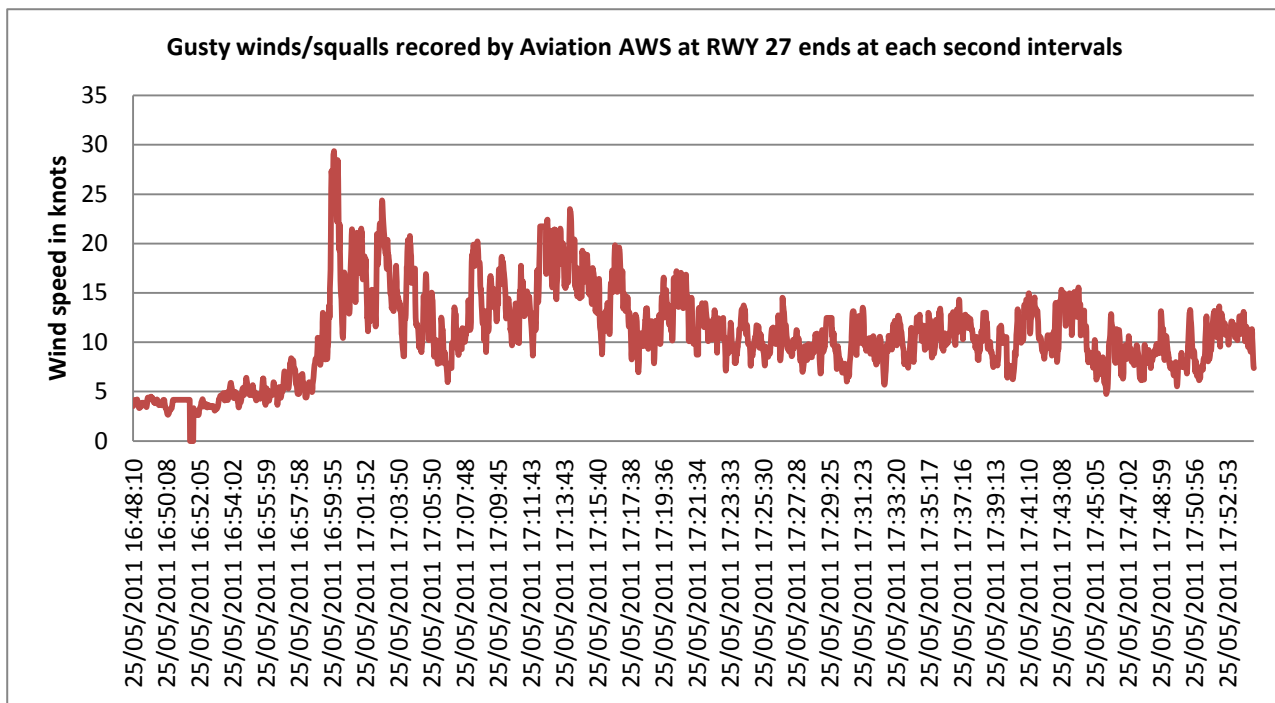
**Fig. 2.** The observations from various Integrated Automatic surface weather Instruments confirms the weather conditions deteriorated at 2230 IST when the RWY 27 end experienced squall/gusty winds of 31 kts/62 kmph from 040 deg which subsequently spread to various other five RWY ends

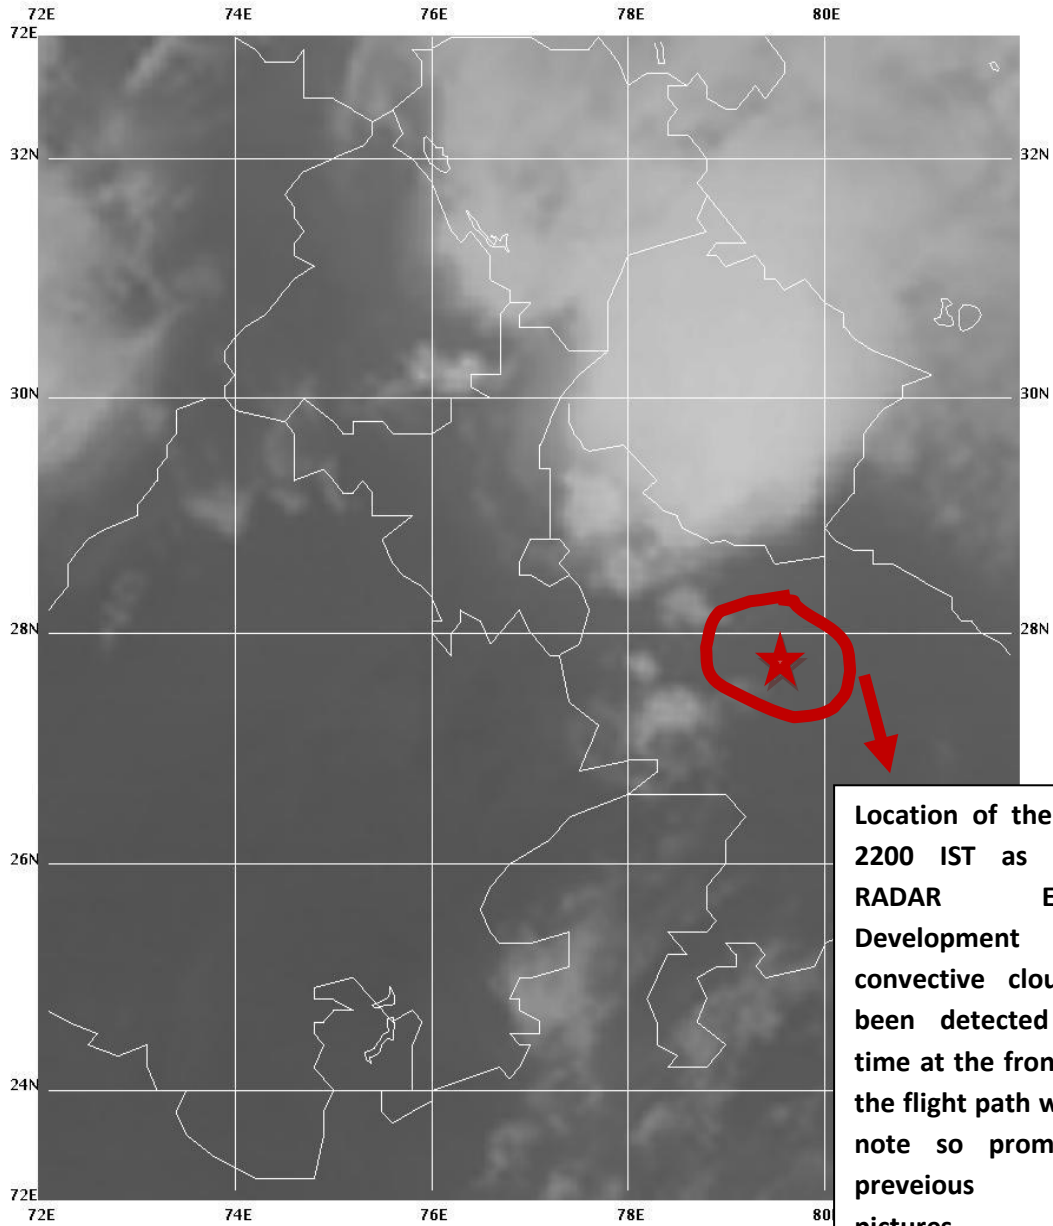
**Fig 3c:** Satellite pictures of North India at 2200 IST

Location of the flight at 2200 IST as per ATC RADAR Estimates. Development of convective clouds have been detected at this time at the front edge of the flight path which was note so prominent at preveious Satellite pictures

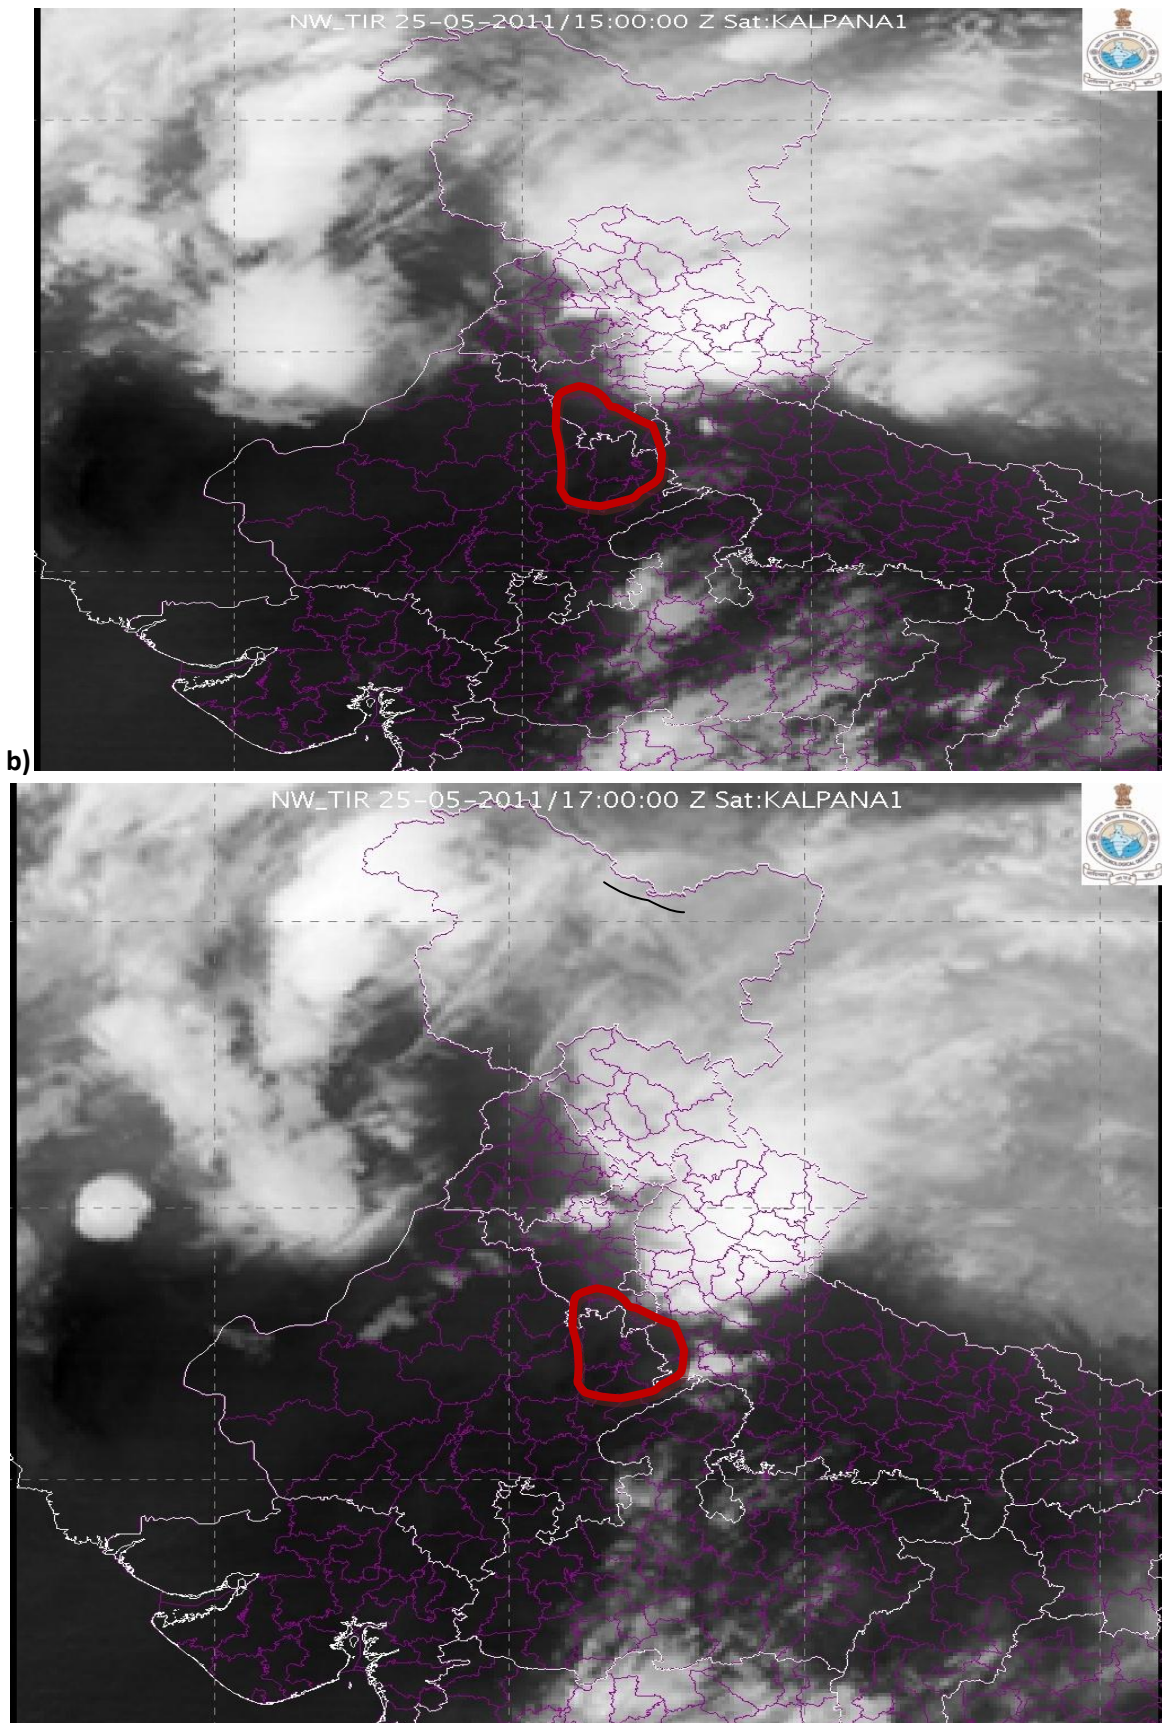
border had occurred during 22:00-23:00 IST when the flight was approaching IGI for landing from Faridabad side. **District wise cloud map from satellite in Fig 4(a-b) of the IMD Report placed as Appx "A", showed development of secondary CB zones by 22:10 IST near but at NE of the airport and east of the airport with in 100km distances, while Fig 5(a-d) of the IMD Report placed as Appx "A", major CB and other cloud pattern still located far at 100-250km at its northeast of IGI Airport which was located over Uttaranchal. DWR estimates in Fig 6(a-b) of the IMD Report placed as Appx "A", indicated these CB clouds had vertical extension up to 12km and these tall CB clouds were at the right approach path of the flight movement which were moving towards ESE sectors. DWR wind estimations Fig 7(a-f) of the IMD Report placed as Appx "A", indicated that the winds at 6500 feet AGL near the affected flight was 70-90kts from North northwest-Very strong turbulences and, the winds at 9800 feet AGL near the affected flight was 30-50kts from South southeast.**

**Fig. 4. a-b, District wise Satellite pictures of North India at 2030 and 2230 IST**

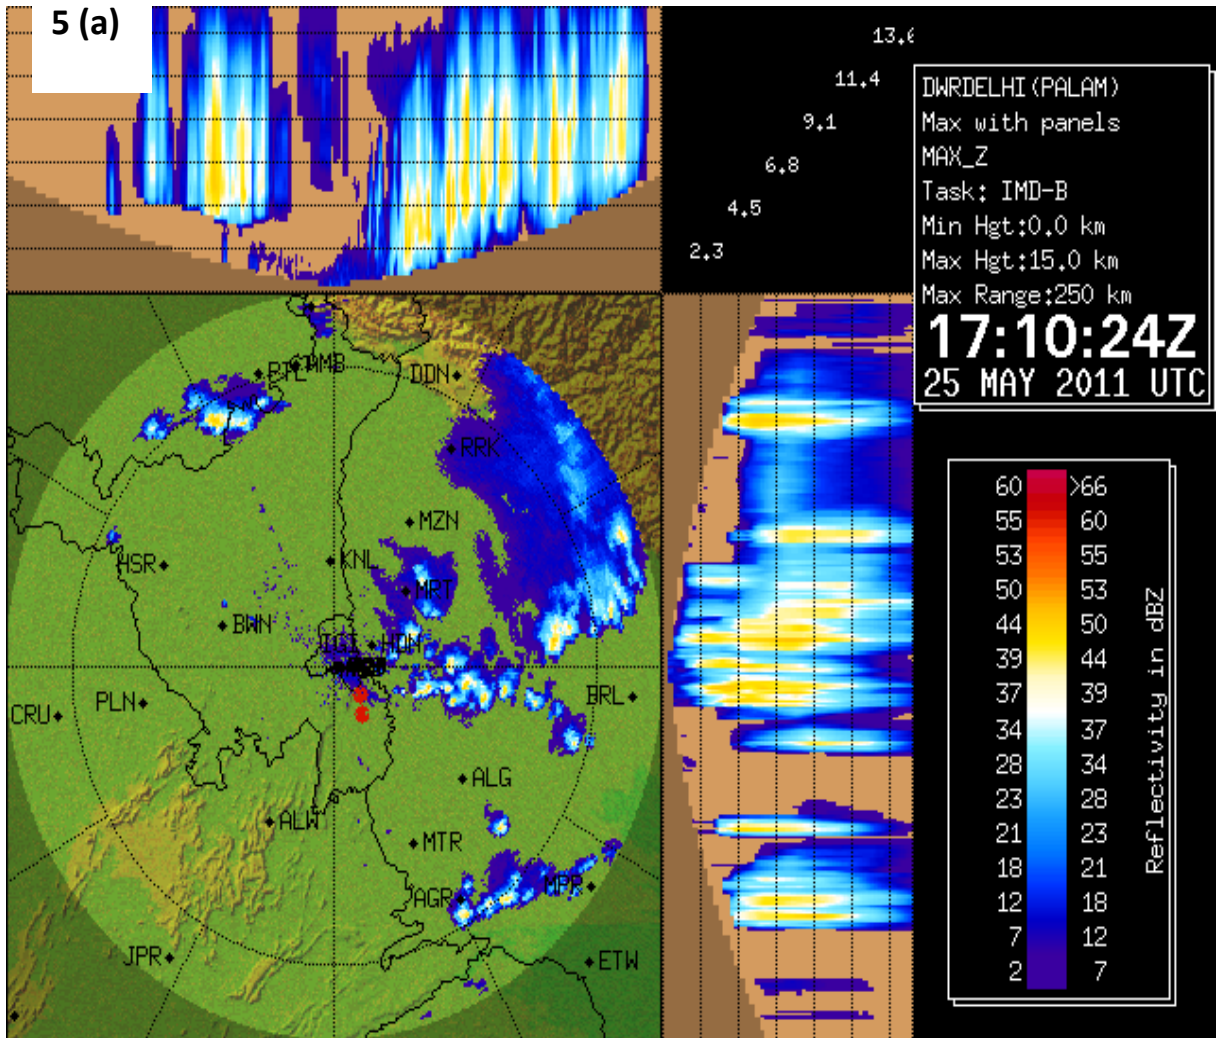
**Fig. 5(a-b). 250km range DWR MAX Z cloud Pictures of the period with the Flight locations (ATC RADAR estimates received from ATC, AAI, during the period 2210-2240 IST**

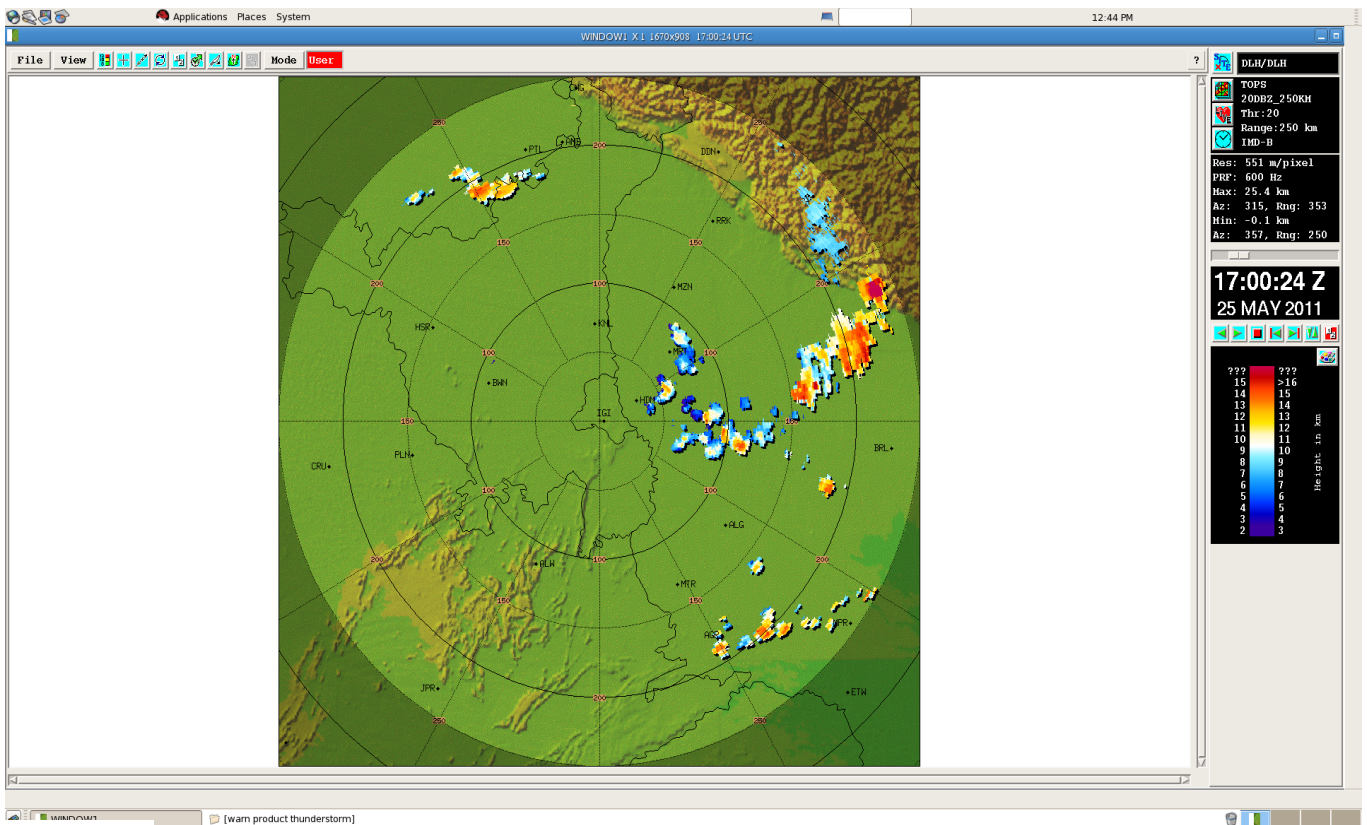
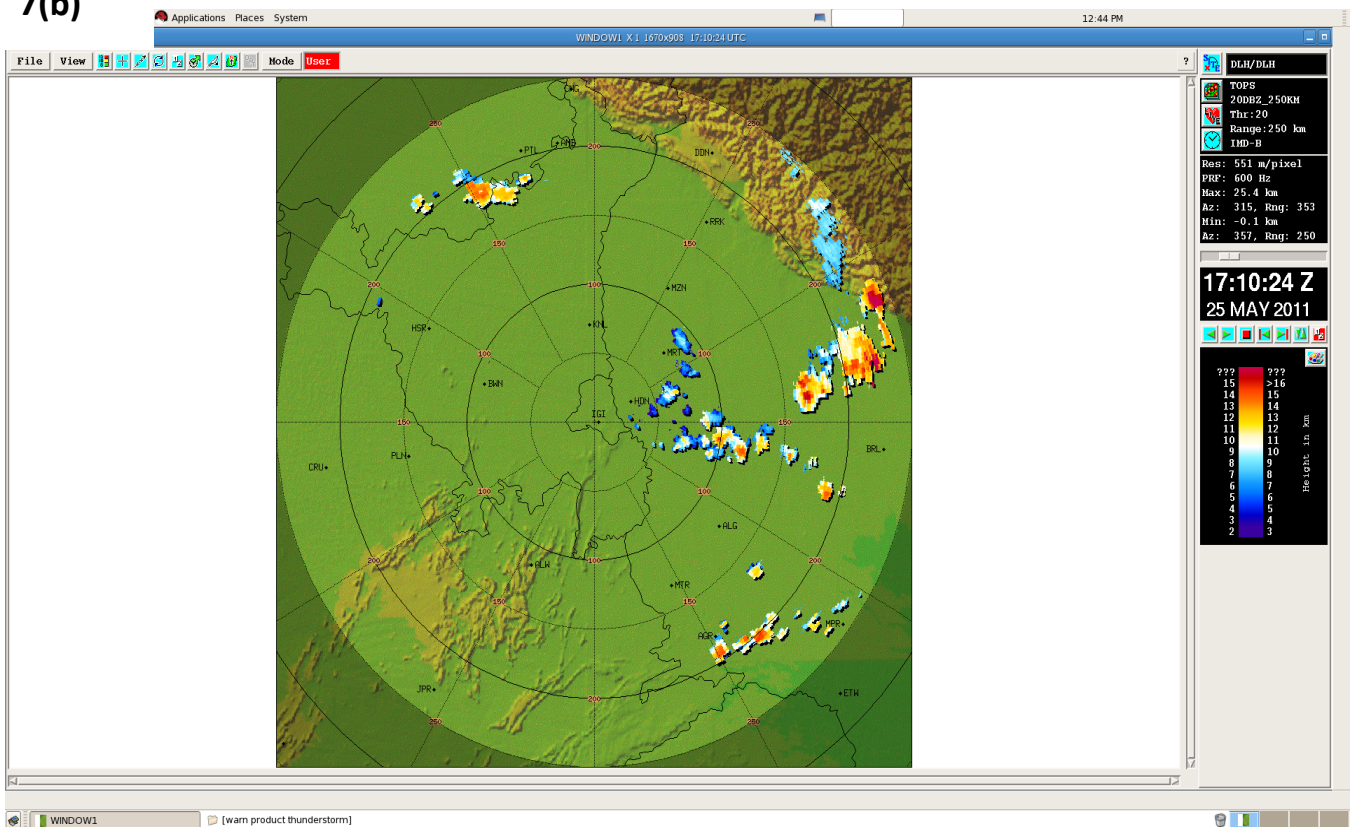
major CB and other cloud pattern still located far at 100-250km at its northeast of IGI Airport which was located over Uttaranchal. DWR cloud heights as per DWR estimates in Fig. 6 a-b show these CB clouds have vertical extension up to 12km as height estimated by DWR and these tall CB clouds were at the right approach path of the flight movement which were moving towards ESE sectors. **Fig.7(a-f) shows wind estimated by DWR at two heights along with corresponding estimated location of the flights from ATC RADAR . It shows in Fig 7 a, c, e-as per DWR wind estimations, the winds at 6500 feet agl near the affected flight was 70-90kts from North northwest-Very strong turbulences and in b, d, f-As per DWR wind estimations, the winds at 9800 feet agl near the affected flight was 30-50kts from South southeast.**

Fig. 7(a-b) CLOUD TOPS FROM DWR shows it was extended upto 8-12km

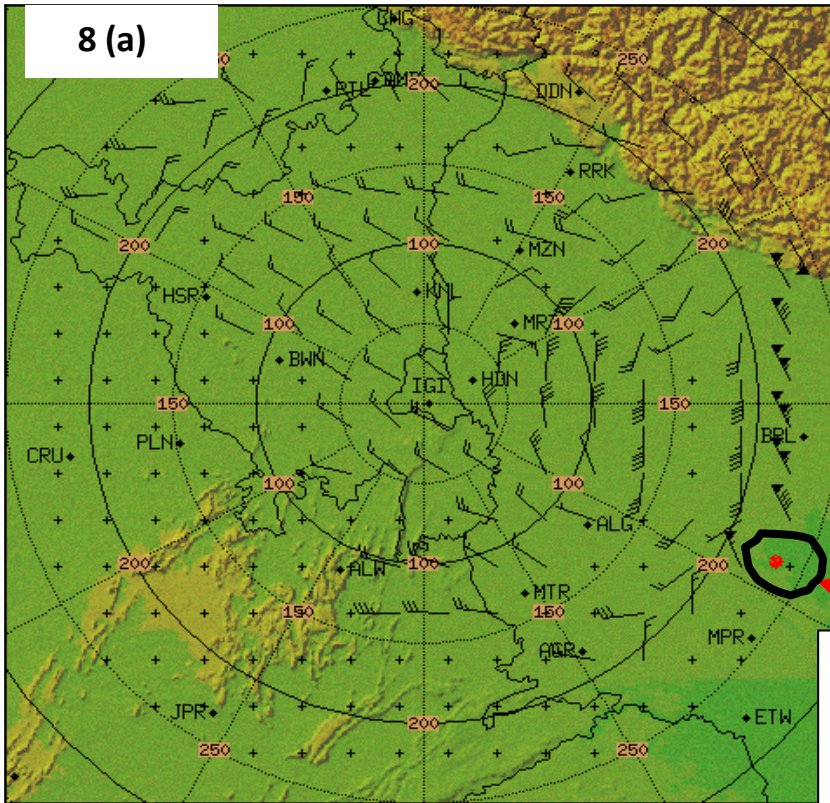
8 (a)

As per DWR wind estimations, the winds at 6500 feet agl near the affected flight was 70-90kts from NNW-Very strong turbulences

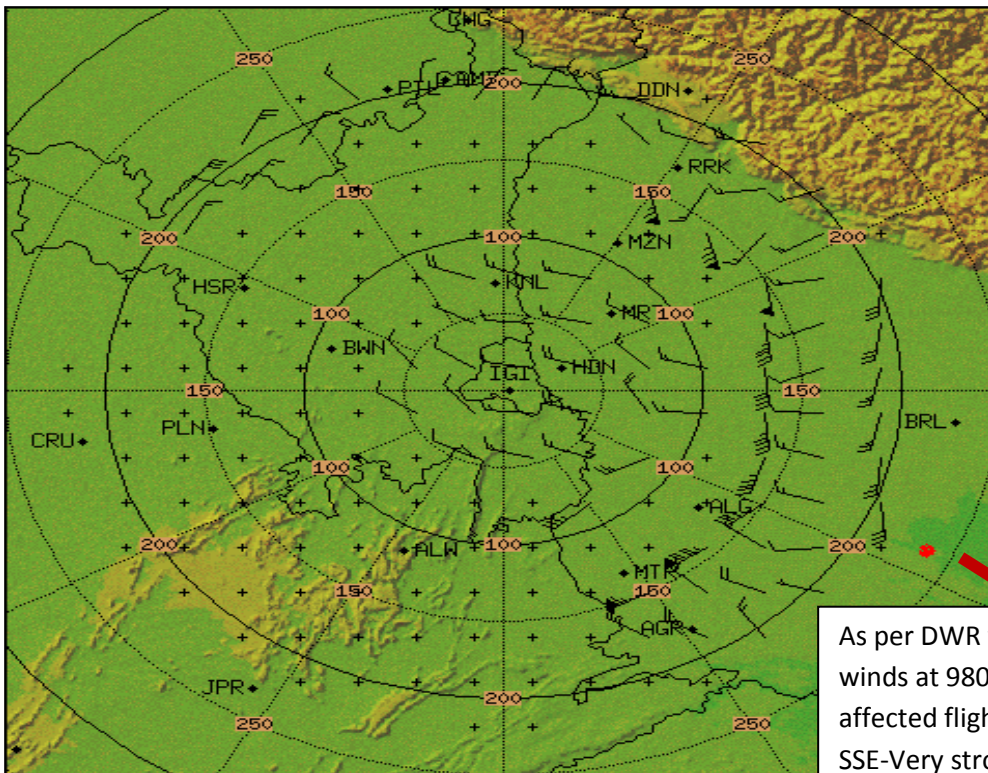
8(b)

As per DWR wind estimations, the winds at 9800 feet agl near the affected flight was 30-50kts from SSE-Very strong turbulences

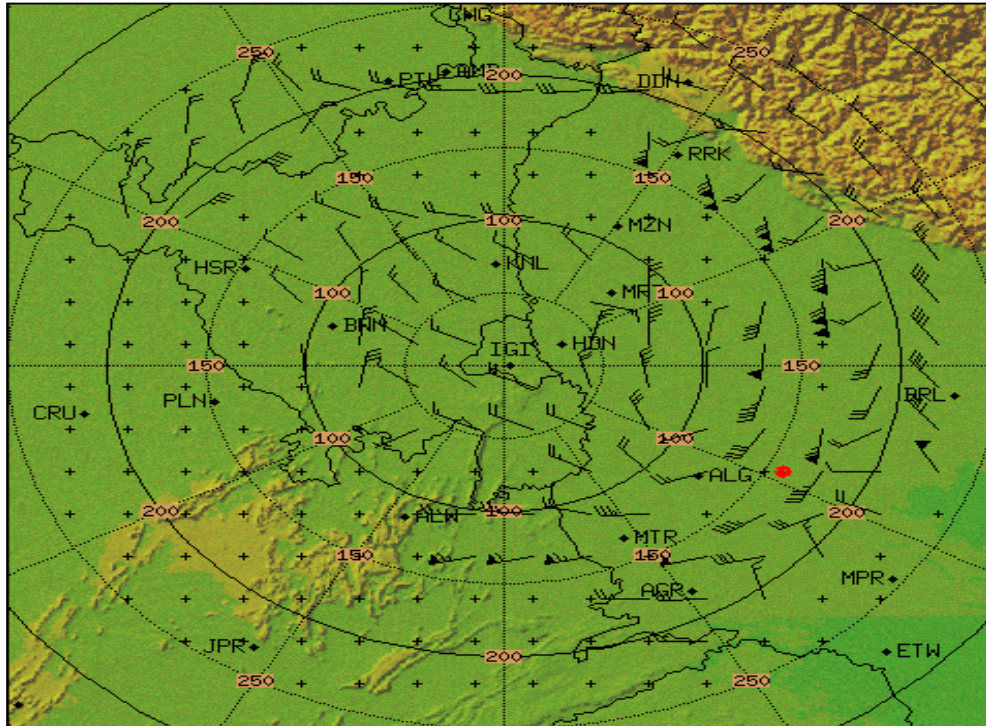
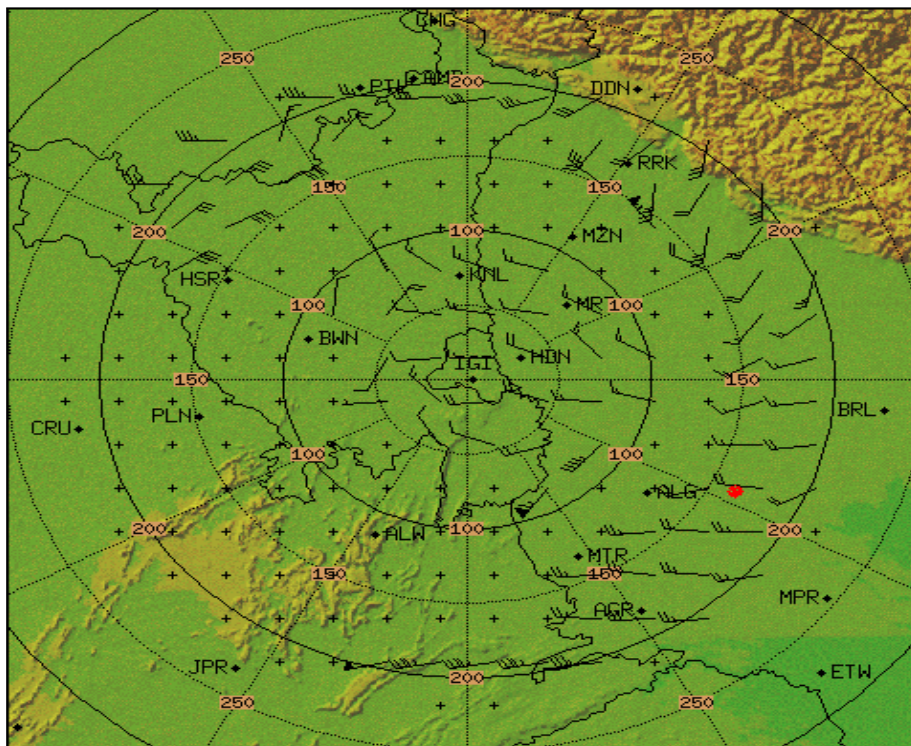
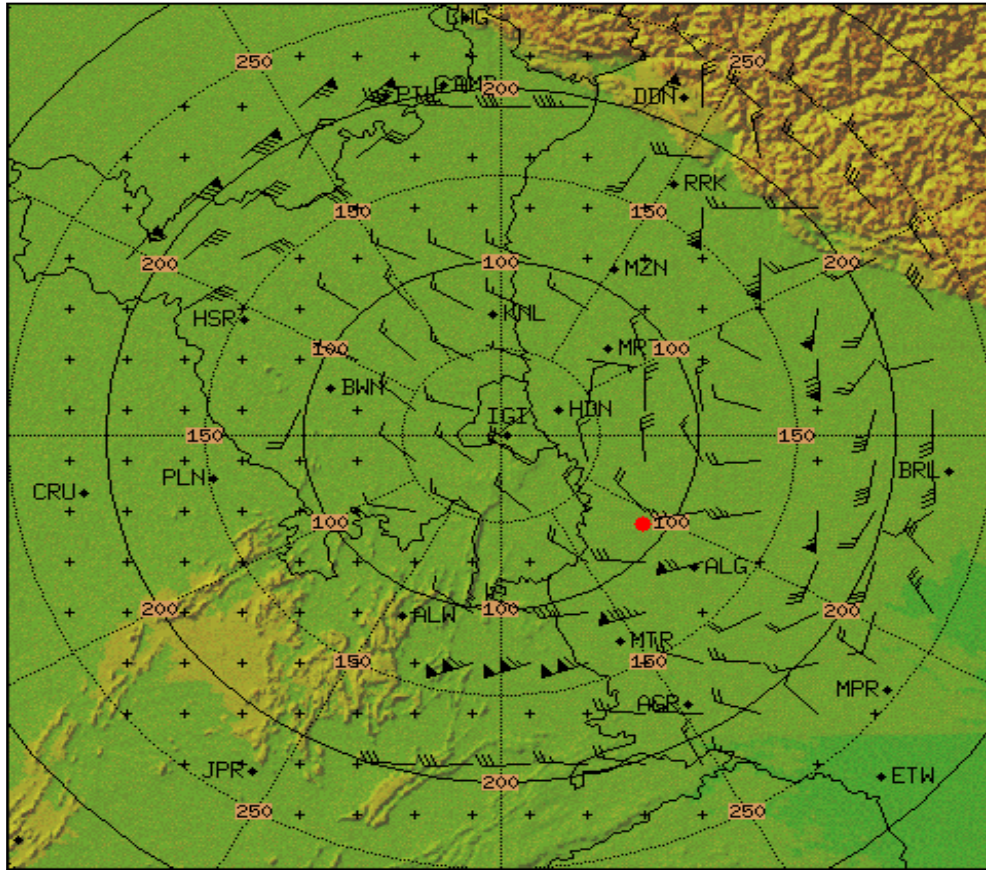
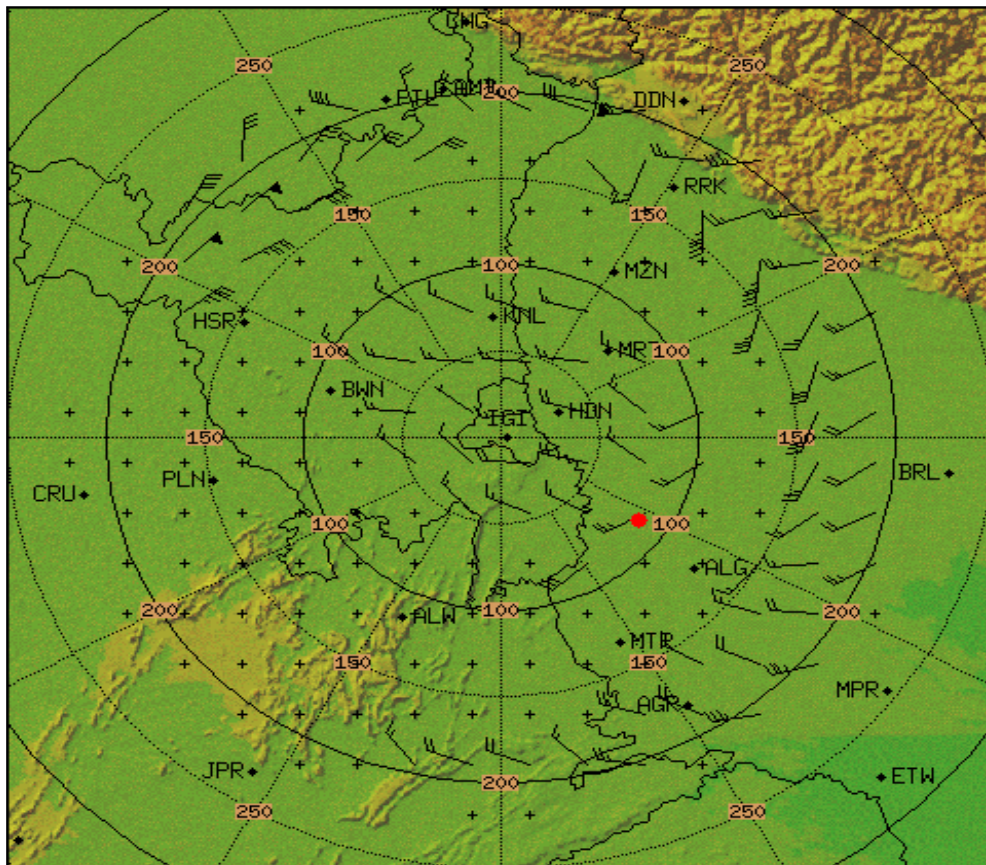
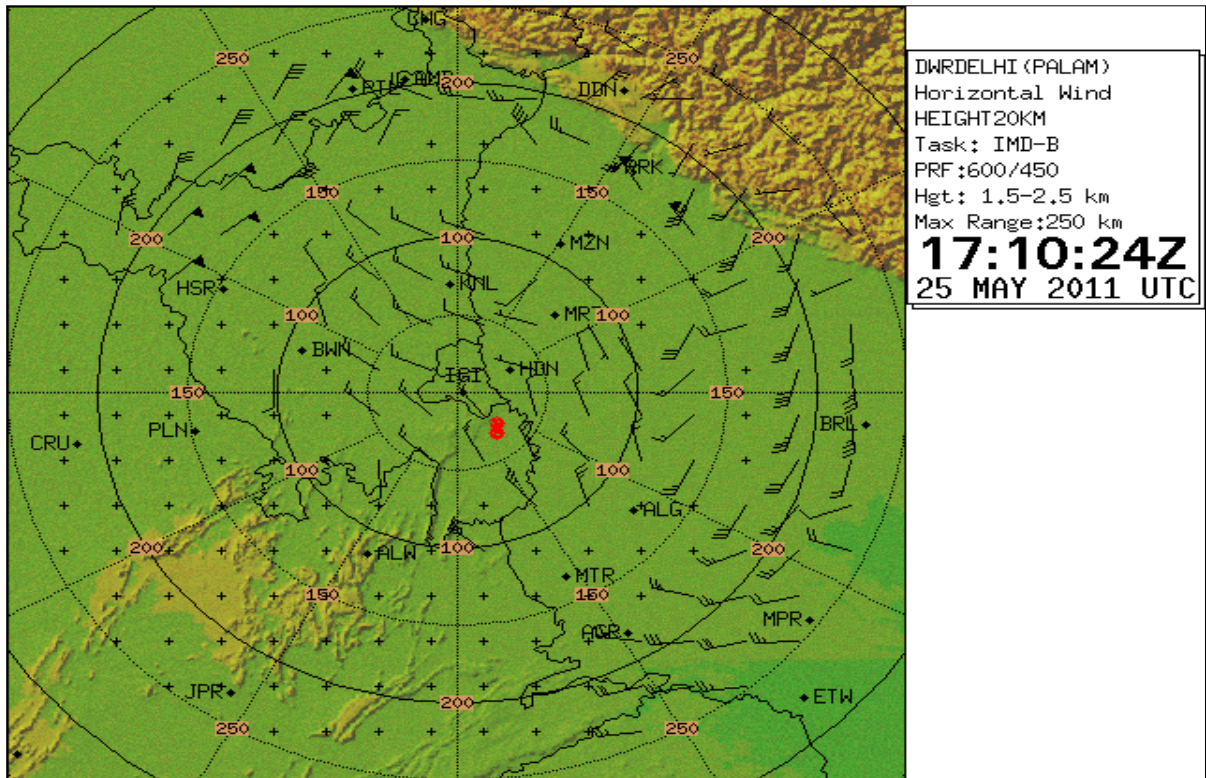
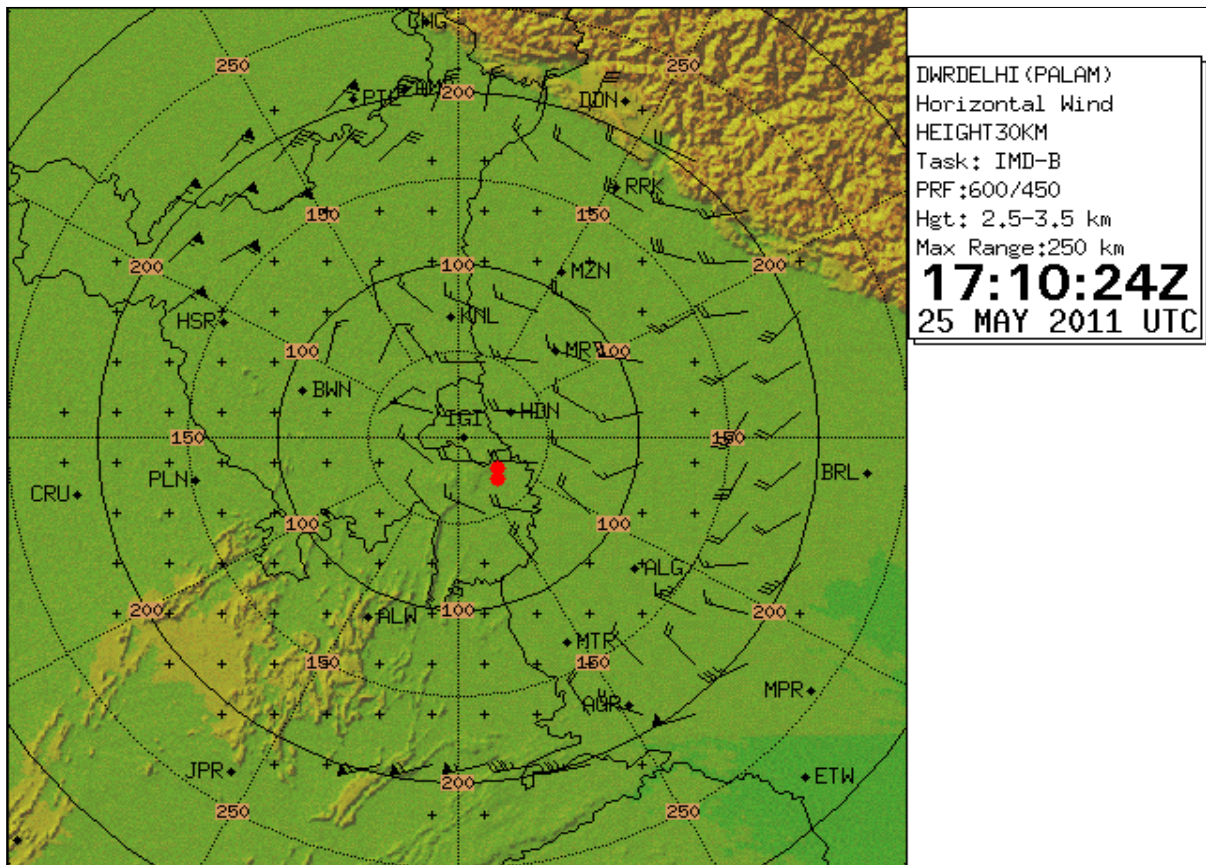
**Fig.8(a-h).** In (a), (c), (e)-as per DWR wind estimations, the winds at 6500 feet above ground level near the affected flight was 70-90kts from NNW and in b, d, f-As per DWR wind estimations, the winds at 9800 feet above ground level near the affected flight was 30-50kts from SSE-Very strong turbulences.
